Preservation Briefs: The Use of Substitute Materials on Historic Building Exteriors

The Use of Substitute Materials on Historic Building Exteriors

Sharon C. Park, AIA

U.S. Department of the Interior
National Park Service
Cultural Resources
Heritage Preservation Services

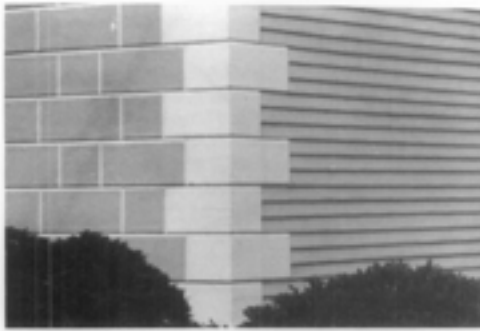
Illus. 1. An early 18th-century technique for imitating carved or quarried stone was the use of sand-impregnated paint applied to wood. The facade stones and quoins are of wood. The Lindens (1754), Washington, D.C. Photo: Sharon C. Park, AIA.

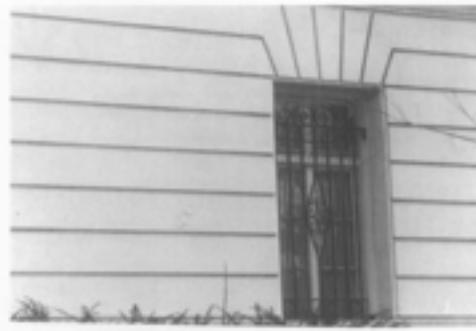
Illus. 2. Stucco has for many centuries represented a number of building materials. Seen here is the ground floor of a Beaux Arts mansion, circa 1900, which represents a finely laid stone foundation wall executed in scored stucco. Photo: Sharon C. Park, AIA.

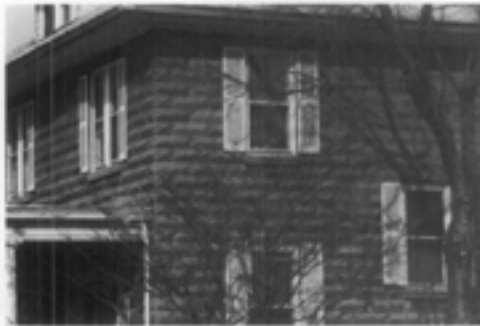
Illus. 3. Casting concrete to represent quarried stone was a popular late 19th-century technique seen in this circa 1910 mail-order house. While most components were delivered by rail, the foundations and exterior masonry were completed by local craftsmen. Photo: Sharon C. Park, AIA.

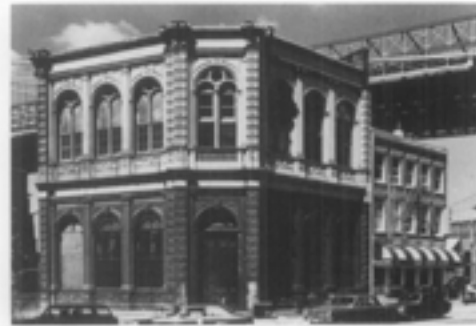
Illus. 4. The 19th-century also produced a variety of metal products used in imitation of other materials. In this case, the entire exterior of the Long Island Safety Deposit Company is cast-iron representing stone. Photo: Becket Logan, Friends of Cast Iron Architecture.

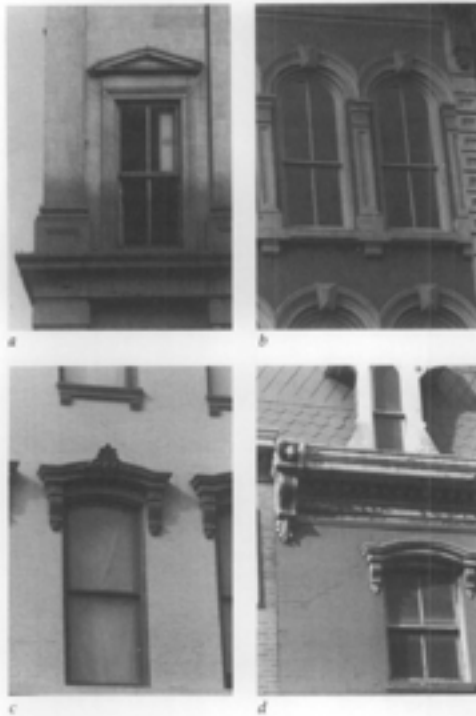
Illus. 5. The four historic examples of various window hoods shown are: (a) stone; (b) cast stone; (c) cast-iron; and (d) sheet metal. The criteria for selecting substitute materials today (availability, quality, delivery dates, cost) are not much different from the past. Photo: Sharon C. Park, AIA.

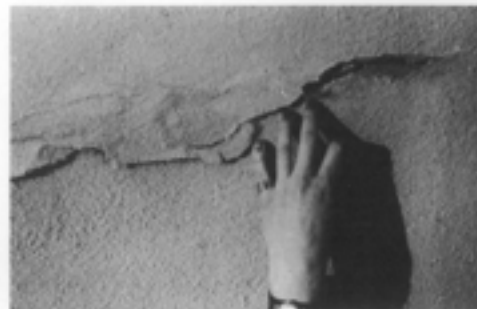
Illus. 6. Substitute materials should never be considered as a cosmetic cover-up for they can cause great physical damage and can alter the appearance of historic buildings. For example, a fiberglass coating was used at Ranchos de Taos, NM, in place of the historic adobe coating which had deteriorated. The waterproof coating sealed moisture in the walls and caused the spalling shown. It was subsequently removed and the walls were properly repaired with adobe. Photo: Lee H. Nelson, FAIA.

Because the overzealous use of substitute materials can greatly impair the historic character of a historic structure, all preservation options should be explored thoroughly before substitute materials are used. It is important to remember that the purpose of repairing damaged features and of replacing lost and irreparably damaged ones is both to match visually what was there and to cause no further deterioration. For these reasons it is not appropriate to cover up historic materials with synthetic materials that will alter the appearance, proportions and details of a historic building and that will conceal future deterioration (see illus. 6).

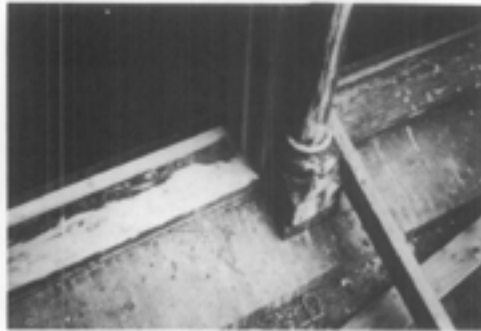
Illus. 7. Whenever possible, historic materials should be repaired rather than replaced. Epoxy, a synthetic resin, has been used to repair the wood window frame and sill at the Auditors Building (1878) Washington, DC. The cured resin is white in this photo and will be primed and painted. Photo: Lee H. Nelson, FAIA.

Some materials have been used successfully for the repair of damaged features such as epoxies for wood infilling, cementitious patching for sandstone repairs, or plastic stone for masonry repairs. Repairs are preferable to replacement whether or not the repairs are in kind or with a synthetic substitute material (see illus. 7).

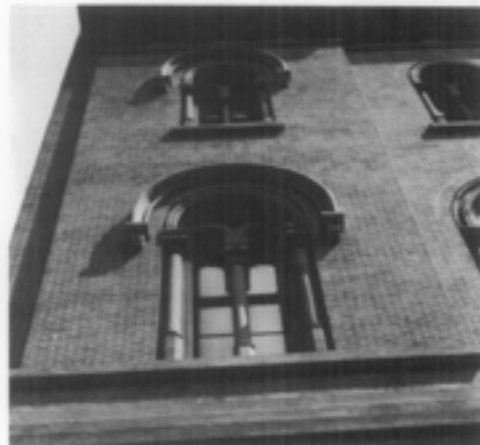
Illus. 8. Even when materials are not locally available, it may be possible and cost effective to find sources elsewhere. For example, the local sandstone was no longer available for the restoration of the New York Shakespeare Festival Public Theater. The deteriorated sandstone window hoods, were replaced with stone from Germany that closely matched the color and texture of the historic sandstone. Photo: John G. Waite.

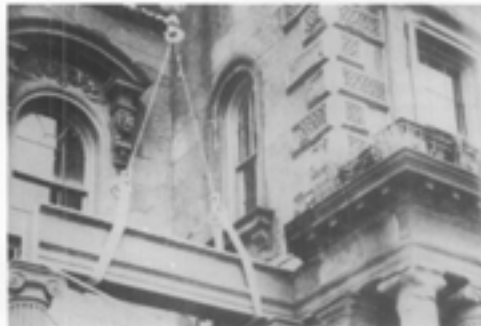
Illus. 9. Simple solutions should not be overlooked when materials are no longer available. In the case of the Morse-Libby Mansion (1859), Portland, ME, the deteriorated brownstone perch beam was replaced with a carved wooden beam painted with sand impregnated paint. Photo: Stephen Sewall.

as a replacement section, achieved using readily available traditional materials, conventional tools and work skills. (see illus. 9). Simple solutions should not be overlooked.

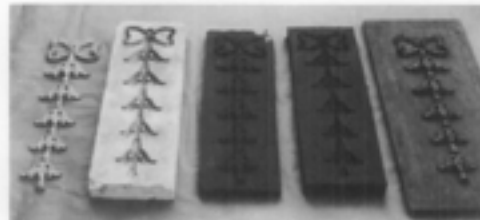
Illus. 10. The use of substitute materials is not necessarily cheaper or easier than using the original materials. The complex process of fabricating the polyester bronze reproduction pieces of the gilded wood molding for the clockcase at Independence Hall required talented artisans and substantial mold-making time. From left to right is the final molded polyester bronze detail; the plaster casting mold; the positive and negative interim neoprene rubber molds; and the expertly carved wooden master. Photo: Courtesy of Independence National Historical Park.

aluminum, cast stone, fiberglass, polymer concretes, glass fiber reinforced concretes and terra cotta. Mold making and casting takes skill and craftsmen who can undertake this work are available. (see illus. 10, 11). Efforts should always be made, prior to replacement, to seek out artisans who might be able to repair ornamental elements and thereby save the historic features in place.

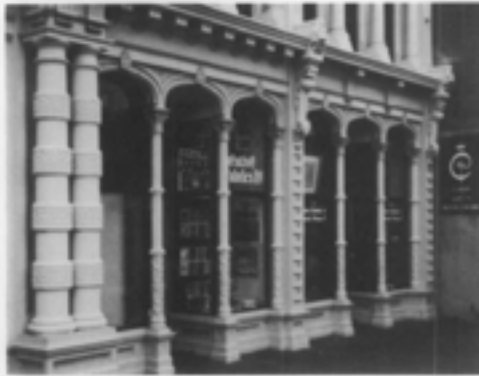
Illus. 11. The unavailability of historic craft techniques is another reason to consider substitute materials. The original first floor cast iron front of the Grand Opera House, Wilmington, DE, was missing; the expeditious reproduction in cast aluminum was possible because artisans working in this medium were available. Photo: John G. Waite.

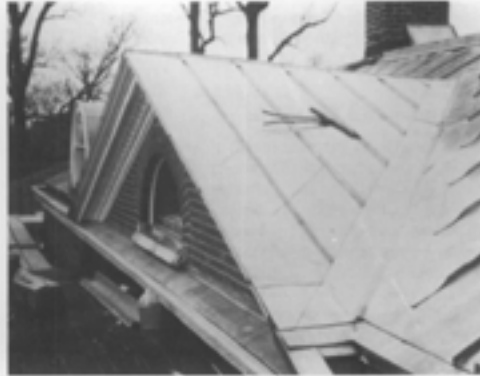
Illus. 12. Substitute materials may be considered when the original materials have not performed well. For example, early sheet metals used for roofing, such as tinplate, were reasonably durable, but the modern equivalent, terne-coated steel, is subject to corrosion once the thin tin plating is damaged. Terne-coated stainless steel or lead-coated copper (shown here) are now used as substitutes. Photo: John G. Waite.

3. Poor original building materials. Some historic building materials were of inherently poor quality or their modern counterparts are inferior. In addition, some materials were naturally incompatible with other materials on the building, causing staining or galvanic corrosion. Examples of poor quality materials were the very soft sandstones which eroded quickly. An example of poor quality modern replacement material is the tin coated steel roofing which is much less durable than the historic tin or terne iron which is no longer available. In some cases, more durable natural stones or precast concrete might be available as substitutes for the soft stones and modern terne-coated stainless steel or lead-coated copper might produce a more durable yet visually compatible replacement roofing (see illus. 12).

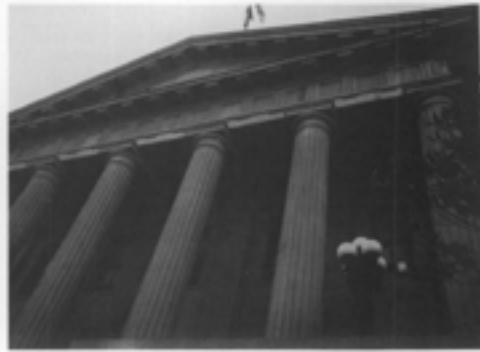
Illus. 13. Code-related changes are of concern in historic preservation projects because the integrity of the historic resource may be irretrievably affected. In the case of the Old San Francisco Mint, the fiberglass cornice was used to bring the building into seismic conformance. The original cornice was deteriorated, and the replacement (1982) was limited to the projecting pediment. The historic stone fascia was retained as were the stone columns. The limited replacement of deteriorated material did not jeopardize the integrity of the building. Photo: Walter M. Sonthheimer.

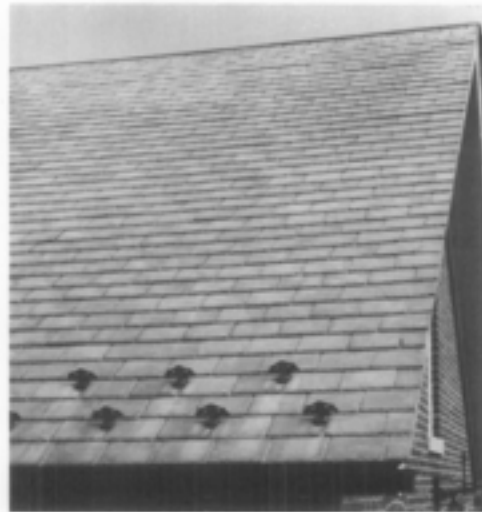
Illus. 14. The visual qualities of the historic feature must be matched when using substitute materials. In this illustration, the lighter weight mineral fiber cement shingles used to replace the deteriorated historic slate roof were detailed to match the color, size, shape and pattern of the original roofing and the historic snow birds were reattached. Photo: Sharon C. Park, AIA.

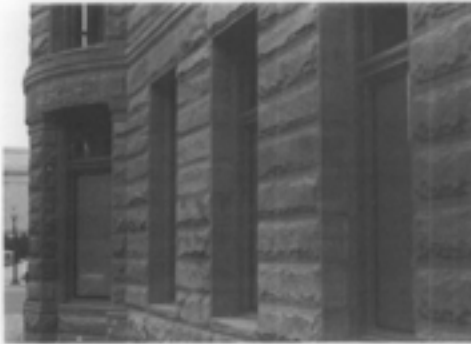
Illus. 16. The good quality substitute materials shown here do match the historic sandstone in color, texture, tooling and surface details. Dry-tamp cast stone was used to match the red sandstone that was no longer available. The reconstructed first floor incorporated both historic and substitute materials. Sufficient molds were made to avoid the problem of detecting the substitutes by their uniformity. Photo: Sharon C. Park, AIA.

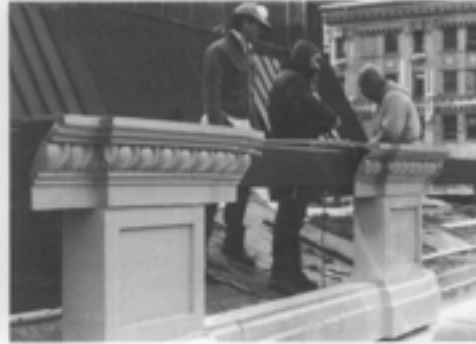
Illus. 18. Substitute materials must be properly installed to allow for expansion, contraction, and structural security. The new balustrade (a polymer concrete modified with glass fibers) at Carnegie Hall, New York City, was installed with steel structural supports to allow window-washing equipment to be suspended securely. In addition, the formulation of this predominantly epoxy material allowed for the natural expansion and contraction within the predesignated joints. Photo: Courtesy of MJM Studios.

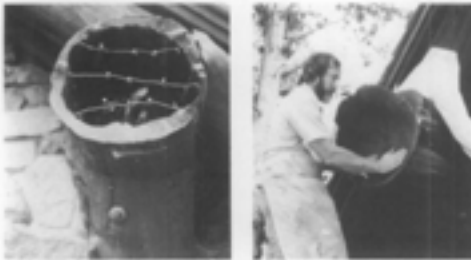
Illus. 17. Care must be taken to ensure that the replacement materials will work within a pre-designed system. At the Norris Museum, Yellowstone National Park, the 12-inch diameter log rafters, part of an intricate truss system, had rotted at the inner core from the exposed ends back to a depth of 48 inches. The exterior wooden shells remained intact. Fiberglass rods (left photo) and specially formulated structural epoxy were used to fill the cleaned out cores and a cast epoxy wafer end with all the detail of the original wood graining was laminated onto the log end (right photo). This treatment preserved the original feature with a combination of repair and replacement using substitute materials as part of a well thought out system. Photos: Courtesy of Harrison Goodall.

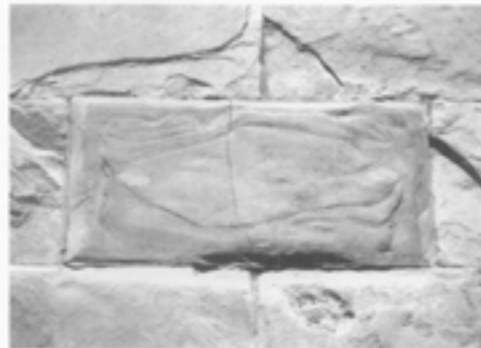
Illus. 19. When the physical properties are not matched, particularly thermal expansion and contraction properties, great damage can occur. In this case, an extremely rigid epoxy replacement unit was installed in a historic masonry wall. Because the epoxy was not modified with fillers, it did not expand or contract systematically with the natural stones in the wall surrounding it. Pressure built up resulting in a vertical crack at the center of the unit, and spalled edges to every historic stone that was adjacent to the rigid unit. Photo: Walter M. Sontheimer.

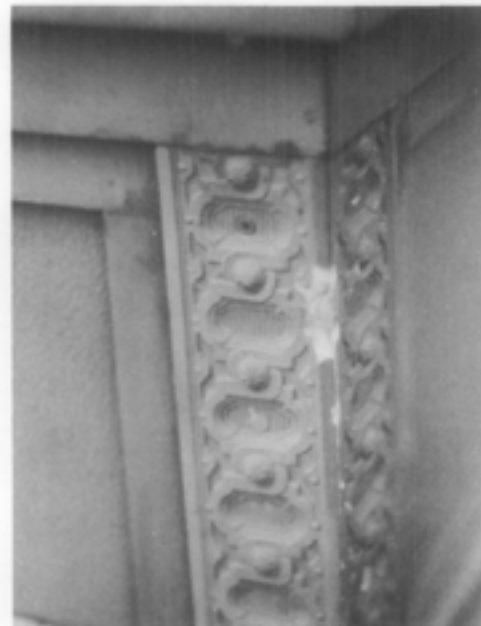
Illus. 20. Long-term performance can be affected by where the substitute material is located. In this case, fiberglass was used as part of a storefront at street level. Due to the brittle nature of the material and the frequency of impact likely to occur at this location, an unsightly chip has resulted. Photo: Sharon C. Park, AIA.

While a substitute material may appear to be acceptable at the time of installation, both its appearance and its performance may deteriorate rapidly. Some materials are so new that industry standards are not available, thus making it difficult to specify quality control in fabrication, or to predict maintenance requirements and long term performance. Where possible, projects involving substitute materials in similar circumstances should be examined. Material specifications outlining stability of color and texture; compressive or tensile strengths if appropriate; the acceptable range of thermal coefficients, and the durability of coatings and finishes should be included in the contract documents. Without these written documents, the owner may be left with little recourse if failure occurs (see illus. 20, 21).

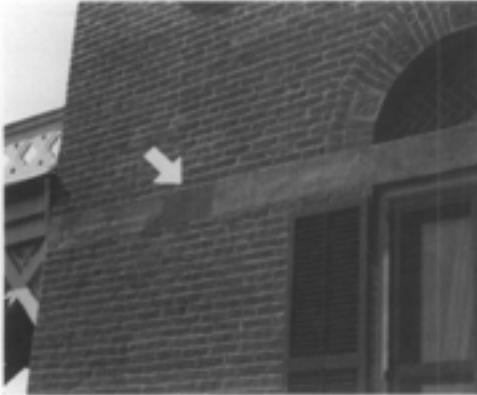
Illus. 21. Change of color over time is one of the greatest problems of synthetic substitute materials used outdoors. Ultra-violet light can cause materials to change color over time; some will lighten and others will darken. In this photograph, the synthetic patching material to the sandstone banding to the left of the window has aged to a darker color. Photos: Sharon C. Park, AIA.

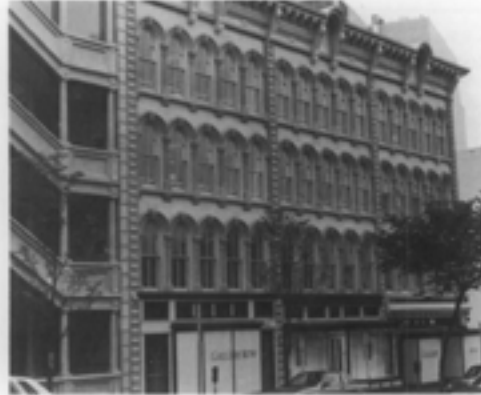
Illus. 22. A fiber reinforced polymer (fiberglass) cornice and precast concrete elements replaced deteriorated features on the 19th-century exterior. Photo: Sharon C. Park, AIA.

Once all reasonable options for repair or replacement in kind have been exhausted, the choice among a wide variety of substitute materials currently on the market must be made (see illus. 22). The charts at the end of this Brief describe a number of such materials, many of them in the family of modified concretes which are gaining greater use. The charts do not include wood, stamped metal, mineral fiber cement shingles and some other traditional imitative materials, since their properties and performance are better known. Nor do the charts include vinyls or molded urethanes which are sometimes used as cosmetic claddings or as substitutes for wooden millwork. Because millwork is still readily available, it should be replaced in kind.

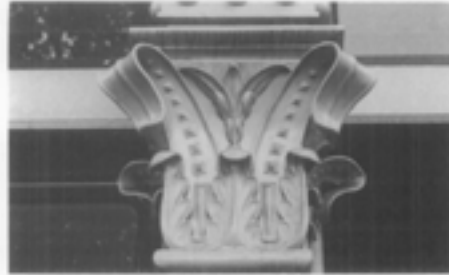
Close-up detail showing the crisp casting in aluminum of this 19th-century replica columns and capital for a storefront. Photo: Sharon C. Park, AIA.

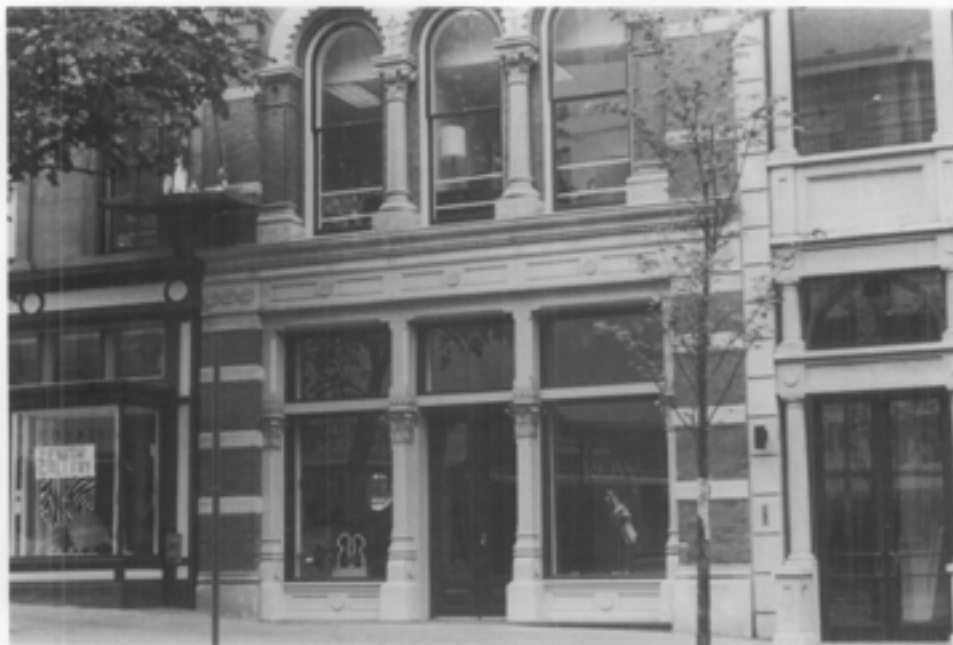
The new cast aluminum storefront replaced the lost 19th-century cast-iron original. Photo: Sharon C. Park, AIA.

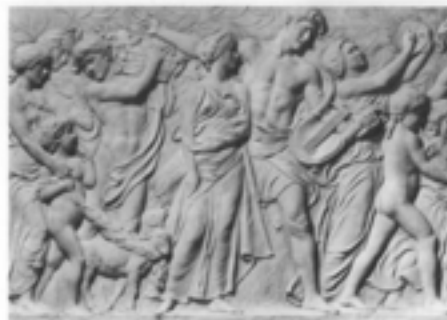
This glass fiber reinforced concrete sculptural wall panel will replace the seriously damaged resin and plaster original. A finely textured surface was achieved by spraying the GFRC mix into molds that were created from the historic panel and resculpted based on historic photographs. Photo: Courtesy of MJM Studios.

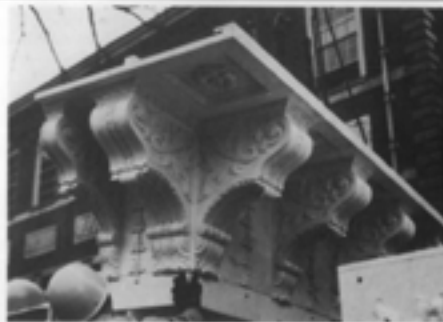
A fiberglass cornice for the reconstruction of an 18th-century wooden clockcase is being lifted in pre-fabricated sections. The level of detail is intricate and of high quality. Photo: Courtesy of Independence National Historical Park.

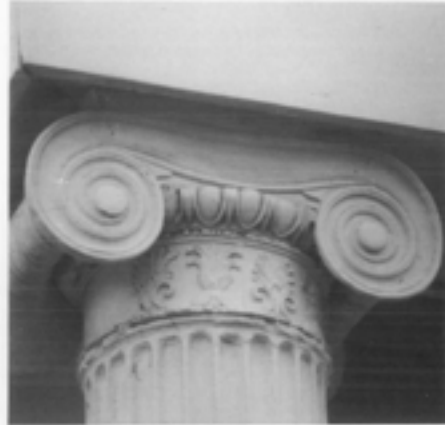
This replica column capital was made using epoxy resins poured into a mold taken from the building. The historic wooden column shaft was repaired during the restoration. Photo: Courtesy Dell Corporation.

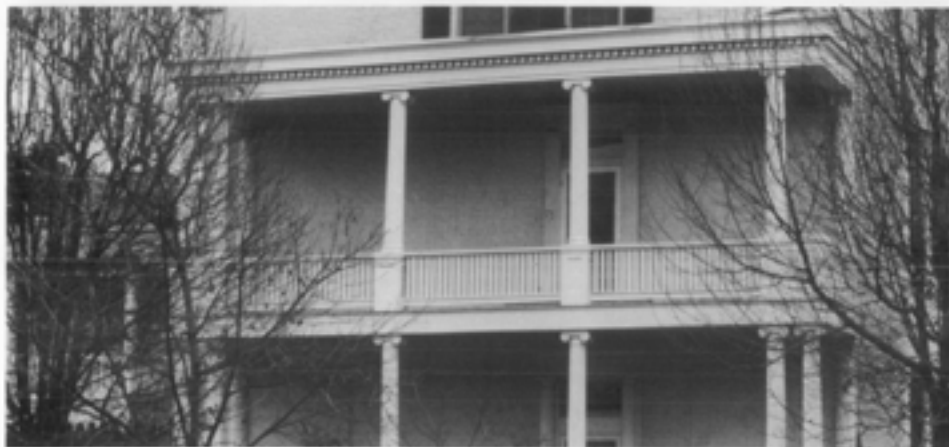
Columns were repaired and a capital was replaced in epoxy on this 19th-century 2-story porch. Photo: Dell Corporation

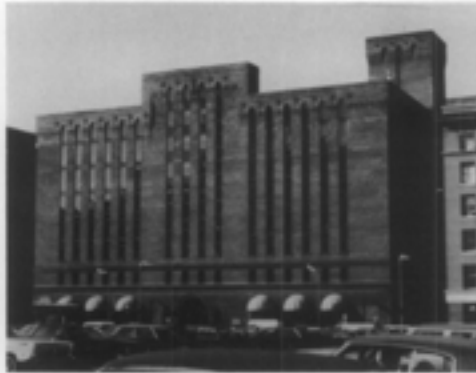
Overall Visual Character: Shape

The shape of a building can be an important aspect of its overall visual character. The building illustrated here, for example, has a distinctive horizontal box-like shape with the middle portion of the box projecting up an extra story. This building has other visual aspects that help define its overall character, including the pattern of vertical bands of windows, the decorative horizontal bands which separate the base of the building from the upper floors, the dark brown color of the brick, the large arched entranceway, and the castle-like tower behind the building.

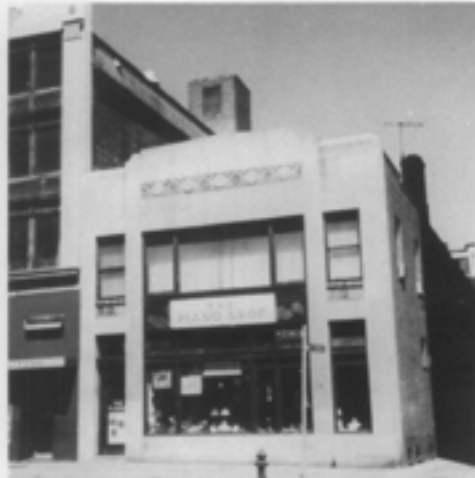
Overall Visual Character: Shape

It should not be assumed that only large or unusual buildings have a shape that is distinctive or identifiable. The front wall of this modest commercial building has a simple three-part shape that is the controlling aspect of its overall visual character. It consists of a large center bay with a two story opening that combines the storefront and the windows above. The upward projecting parapet and the decorative stonework also relate to and emphasize its shape. The flanking narrow bays enframe the side windows and the small iron balconies, and the main entrance doorway into the store. Any changes to the center portion of this three-part shape, could drastically affect the visual character of this building. Photo by Emogene A. Bevitt

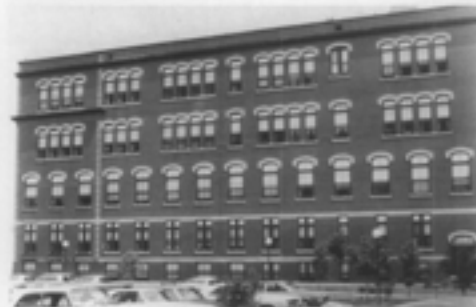
Overall Visual Character: Openings

Window and door openings can be important to the overall visual character of historic buildings. This view shows only part of a much larger building, but the windows clearly help define its character, partly because of their shape and rhythm: the upper floor windows are grouped in a 4,3,4,1,4 rhythm, and the lower floor windows are arranged in a regular 1,1,1... rhythm. The individual windows are tall, narrow and arched, and they are accented by the different colored arched heads, which are connected where there are multiple windows so that the color contrast is a part of its character. If additional windows were inserted in the gap of the upper floors, the character would be much changed, as it would if the window heads were painted to match the color of the brick walls. Photo by Susan I. Dynes

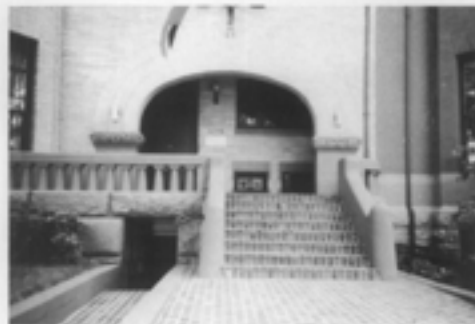
Overall Visual Character: Openings

The opening illustrated here dominates the visual character of this building because of its size, shape, location, materials, and craftsmanship. Because of its relation to the generous staircase, this opening places a strong emphasis on the principal entry to the building. Enclosing this arcade-like entry with glass, for example, would materially and visually change the character of the building. Photo by Lee H. Nelson.

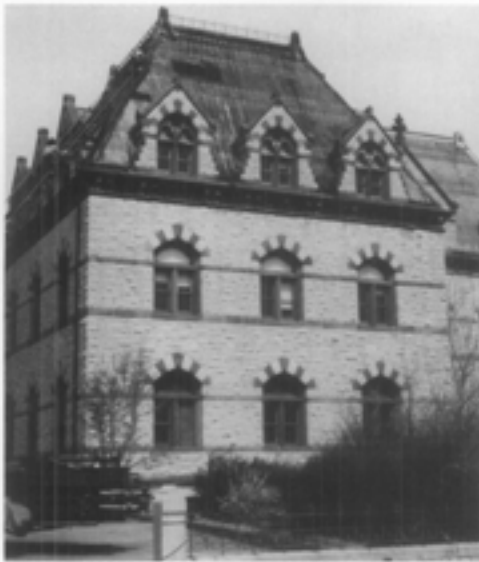
Overall Visual Character: Roof and Related Features

This building has a number of character-defining aspects which include the windows and the decorative stonework, but certainly the roof and its related features are visually important to its overall visual character. The roof is not only highly visible, it has elaborate stone dormers, and it also has decorative metalwork and slatework. The red and black slates of differing sizes and shapes are laid in patterns that extend around the roof of this large and freestanding building. Any changes to this patterned slatework, or to the other roofing details would damage the visual character of the building. Photo by Laurie R. Hammel

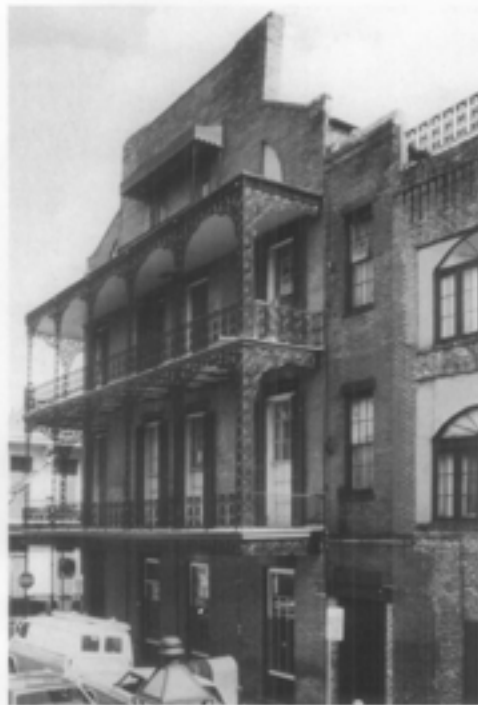
Overall Visual Character: Projections

A projecting porch or balcony can be very important to the overall visual character of almost any building and to the district in which it is located. Despite the size of this building (3 1/2 stories), and its distinctive roofline profile, and despite the importance of the very large window openings, the lacy wrap-around iron balcony is singularly important to the visual character of this building. It would seriously affect the character to remove the balcony, to enclose it, or to replace it with a balcony lacking the same degree of detail of the original material. Photo by Baird M. Smith

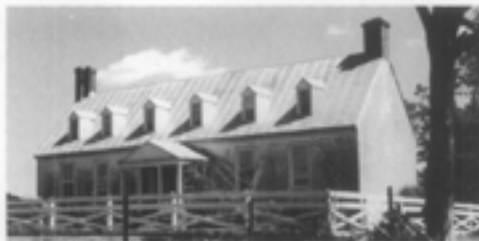
Overall Visual Character: Roof and Related Features

On this building, the most important visual aspects of its character are the roof and its related features such as the dormers and chimneys. The roof is important to the visual character because its steepness makes it highly visible, and its prominence is reinforced by the patterned tinwork, the six dormers and the two chimneys. Changes to the roof or its features, such as removal or alterations to the dormers, for example, would certainly change the character of this building. This does not discount the importance of its other aspects, such as the porch, the windows, the brickwork, or its setting; but the roof is clearly crucial to understanding the overall visual character of this building as seen from a distance. Photo by Lee H. Nelson

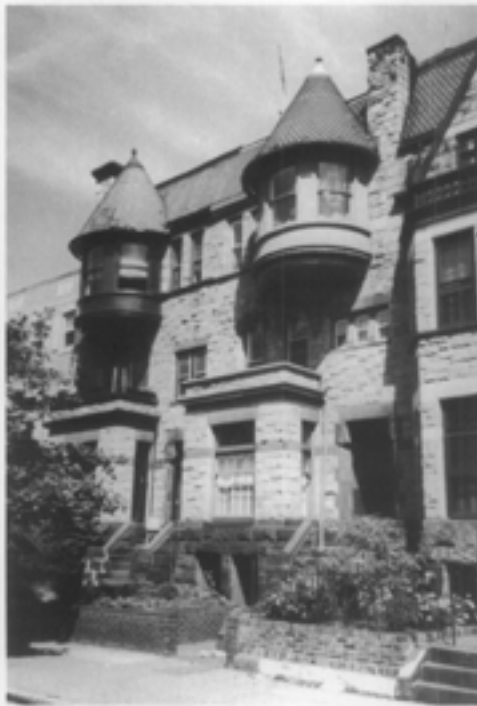
Overall Visual Character: Projections

Since these are row houses, any evaluation of their visual exterior character is necessarily limited to the front and rear walls; and while there are a number of things competing for attention in the front, it is the half round projecting bays with their conical roofs that contribute most prominently to the visual character. Their removal would be a devastating loss to the overall character, but even if preserved, the character could be easily damaged by changes to their color (as seen in the left bay which has been painted a dark color), or changes to their windows, or changes to their tile roofs. Though these houses have other fine features that contribute to the visual character and are worthy of preservation, these half-round bays demonstrate the importance of projecting features on an already rich and complex facade. Because of the repetitive nature of these projecting bays on adjacent row houses, along with the buildings' size, scale, openings, and materials, they also contribute to the overall visual character of the streetscape in the historic district. Any evaluation of the visual character of such a building should take into account the context of this building within the district. Photo by Lee H. Nelson

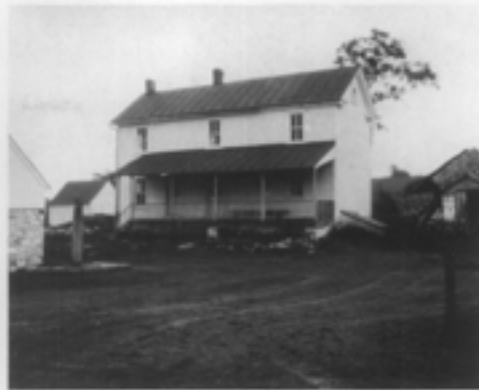
Overall Visual Character: Projections

Many buildings have projecting features such as porches, bay windows, or overhanging roofs, that help define their overall visual character. This projecting porch because of its size and shape, and because it copies the pitch and material of the main roof, is an important contributor to the visual character of this simple farmhouse. The removal or alteration of this porch would drastically alter the character of this building. If the porch were enclosed with wood or glass, or if gingerbread brackets were added to the porch columns, if the tin roof was replaced with asphalt, or if the porch railing was opened to admit a center stairway, the overall visual character could be seriously damaged. Although this projecting porch is an important feature, almost any other change to this house, such as changes to the window pattern, or changes to the main roof, or changes to the setting, would also change its visual character. Photo by Hugh C. Miller

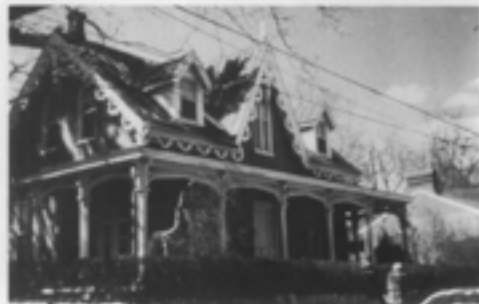
Overall Visual Character: Trim

If one were to analyze the overall shape or form of this building, it would be seen that it is a gable-roofed house with dormers and a wrap-around porch. It is similar to many other houses of the period. It is the wooden trim on the eaves and around the porch that gives this building its own identity and its special visual character. Although such wooden trim is vulnerable to the elements, and must be kept painted to prevent deterioration; the loss of this trim would seriously damage the overall visual character of this building, and its loss would obliterate much of the close-up visual character so dependent upon craftsmanship for the moldings, carvings, and the see-through jigsaw work. Photo by Hugh C. Miller

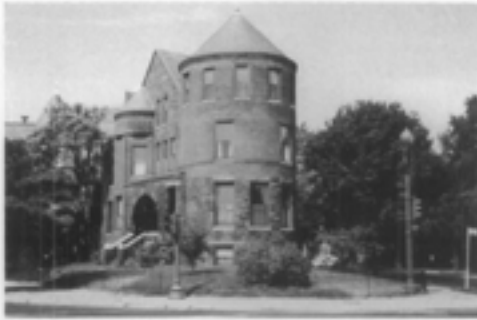
Overall Visual Character: Setting

In this instance, the corner tower and the arched entryway are important contributors to the visual character of the building itself, but there is also a relationship between the building and the two converging streets that is also an important aspect of this historic building. The curb, sidewalk, fence, and the yard interrelate with each other to establish a setting that is essential to the overall visual character of the historic property. Removing these elements or replacing them with a driveway or parking court would destroy an important visual aspect. Photo by Lee H. Nelson

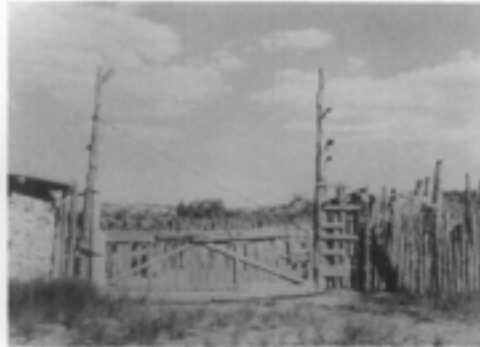
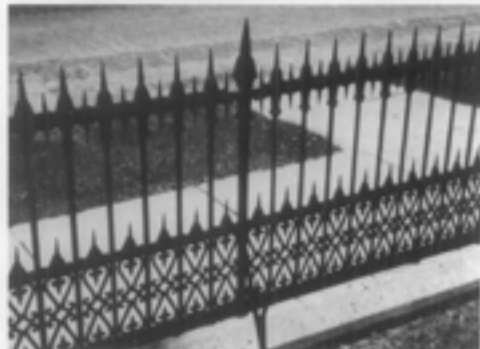
Overall Visual Character: Setting

Among the various visual aspects relating to the setting of an historic property are such site features as gardens, walks, fences, etc. This can include their design and materials.

There is a dramatic difference in the visual character between these two fence constructions—one utilizing found materials with no particular regard to their uniformity of size or placement, and the other being a product of the machine age utilizing cast iron components assembled into a pattern of precision and regularity. If the coral fence were to be repaired or replaced with lumberyard materials its character would be dramatically compromised. The rhythm and regularity of the cast iron fence is so important to its visual character that its character could be altered by accidental damage or vandalism, if some of the fence top spikes were broken off thus interrupting the rhythm or pattern. Photos by Lee H. Nelson

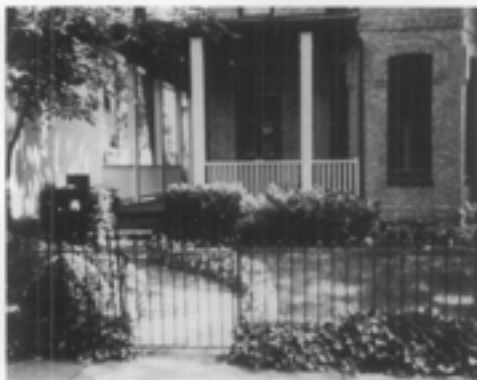
Overall Visual Character: Setting

Even architecturally modest buildings frequently will have a setting that contributes to their overall character. In this very urban district, set-backs are the exception, so that the small front yard is something of a luxury, and it is important to the overall character because of its design and materials, which include the iron fence along the sidewalk, the curved walk leading to the porch, and the various plantings. In a district where parking spaces are in great demand, such front yards are sometimes converted to off-street parking, but in this instance, that would essentially destroy its setting and would drastically change the visual character of this historic property. Photo by Lee H. Nelson

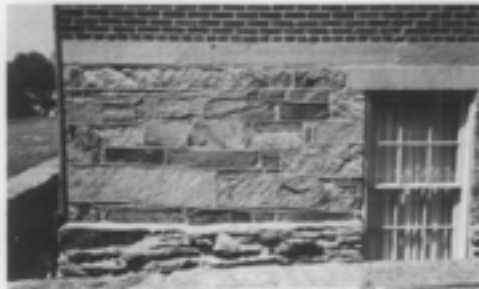
Arm's Length Visual Character: Materials

At arm's length, the visual character is most often determined by the surface qualities of the materials and craftsmanship, and while these aspects are often inextricably related, the original choice of materials often plays the dominant role in establishing the close-range character because of the color, texture, or shape of the materials.

In this instance, the variety and arrangement of the materials is important in defining the visual character, starting with the large pieces of broken stone which form the projecting base for the building walls, then changing to a wall of roughly rectangular stones which vary in size, color, and texture, all with accentuated, projecting beads of mortar, then there is a rather precise and narrow band of cut and dressed stones with minimal mortar joints, and finally, the main building walls are composed of bricks, rather uniform in color, with fairly generous mortar joints. It is the juxtaposition and variety of these materials (and of course, the craftsmanship) that is very important to the visual character. Changing the raised mortar joints, for example, would drastically alter the character at arm's length. Photo by Lee H. Nelson

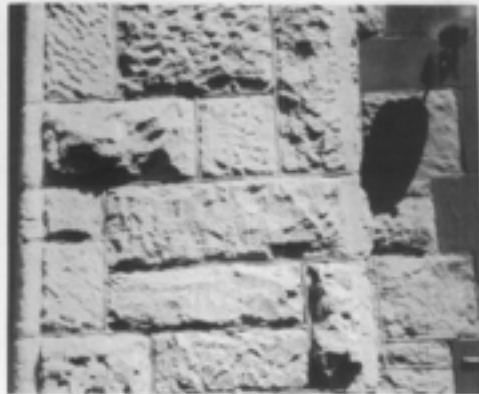
Arm's Length Visual Character: Craft Details

There are many instances where craft details dominate the arm's length visual character. As seen here, the craft details are especially noticeable because the stones are all of a uniform color, and they are all squared off, but their surfaces were worked with differing tools and techniques to create a great variety of textures, resulting in a tour-de-force of craft details. This texture is very important at close range. It was a deliberately contrived surface that is an important contributor to the visual character of this building. Photo by Lee H. Nelson

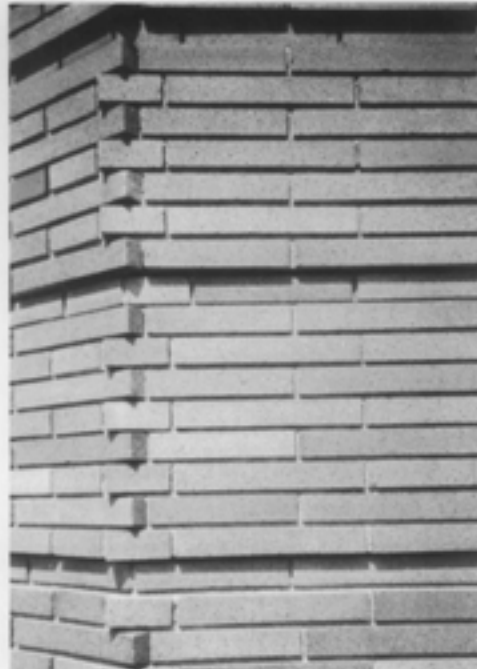
Arm's Length Visual Character: Craft Details

The arm's length visual character of this building is a combination of the materials and the craft details. Most of the exterior walls of this building consist of early 20th century Roman brick, precisely made, unusually long bricks, in varying shades of yellow-brown, with a noticeable surface spotting of dark iron pyrites. While this brick is an important contributor to the visual character, the related craft details are perhaps more important, and they consist of: unusually precise coursing of the bricks, almost as though they were laid up using a surveyor's level; a row of recessed bricks every ninth course, creating a shadow pattern on the wall; deeply recessed mortar joints, creating a secondary pattern of shadows; and a toothed effect where the bricks overlap each other at the corner of the building. The cumulative effect of this artisanship is important to the arm's length visual character, and it is evident that it would be difficult to match if it were damaged, and the effect could be easily damaged through insensitive treatments such as painting the brickwork or by careless repointing. Photo by Lee H. Nelson

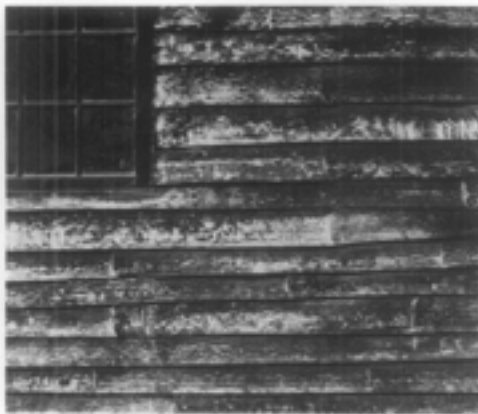
Arm's Length Visual Character: Craft Details

On some buildings, there are subtle aspects of visual character that cannot be perceived from a distance. This is especially true of certain craft details that can be seen only at close range. On this building, it is easily understood that the narrow, unpainted, and weathered clapboards are an important aspect of its overall visual character; but at close range there are a number of subtle but very important craft details that contribute to the handmade quality of this building, and which clearly differentiate it from a building with machine sawn clapboards. The clapboards seen here were split by hand and the bottom edges were not dressed, so that the boards vary in width and thickness, and thus they give a very uneven shadow pattern. Because they were split from oak that is unpainted, there are occasional wavy rays in the wood that stand against the grain. Also noticeable is the fact that the boards are of relatively short lengths, and that they have feather-edged ends that overlap each other, a detail that is very different from butted joints. The occasional large nail heads and the differential silver-gray weathering add to the random quality of the clapboards. All of these qualities contribute to the arm's length visual character. Photo by Lee H. Nelson

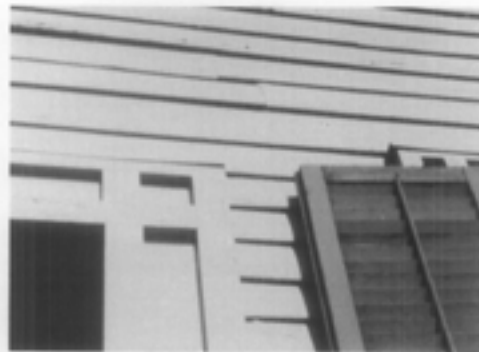
Arm's Length Visual Character: Craft Details

While hand-split clapboards are distinctive visual elements in their own way, machine-sawn and painted wood siding is equally important to the overall visual character in most other instances. At arm's length, however, the machine-sawn siding may not be so distinctive; but there might be other details that add visual character to the wooden building, such as the details of wooden trim and louvered shutters around the windows (as seen here), or similar surface textures on other buildings, such as the saw marks on wall shingles, the joints in leaded glass, decorative tinwork on a rain conductor box, the rough surface of pebble-dash stuccowork, or the pebbly surface of exposed aggregate concrete. Such surfaces can only be seen at arm's length and they add to the visual character of a historic building. Photo by Hugh C. Miller

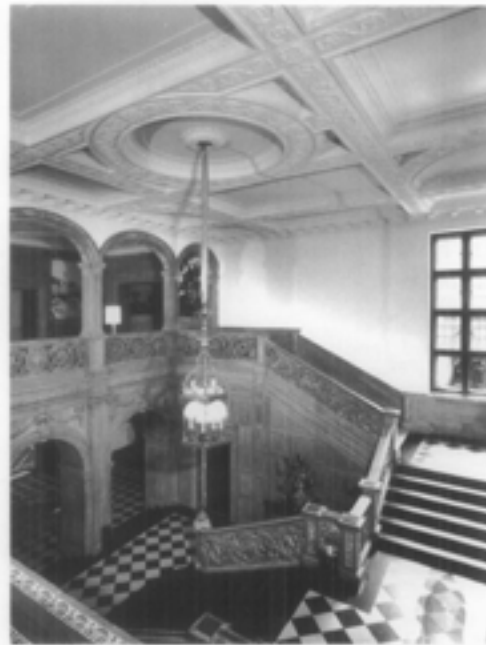
Figure 1. This architect-designed interior reflects early 20th century American taste: the checkerboard tile floor, wood wainscot, coffered ceiling, and open staircase are richly detailed and crafted by hand. Not only are the individual architectural features worthy of preservation, but the planned sequence of spaces—entry hall, stairs, stair landings, and loggia—imparts a grandeur that is characteristic of high style residences of this period. This interior is of Greystone, Los Angeles, California. Photography for HABS by Jack E. Boucher

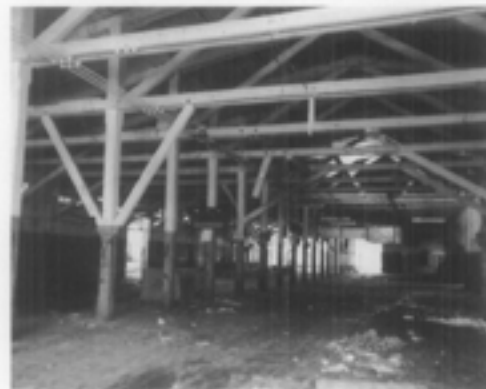
Figure 2. The interiors of mills and industrial buildings frequently are open, unadorned spaces with exposed structural elements. While the new uses to which this space could be put are many—retail, residential, or office—the generous floor-to-ceiling height and exposed truss system are important character-defining features and should be retained in the process of rehabilitation.

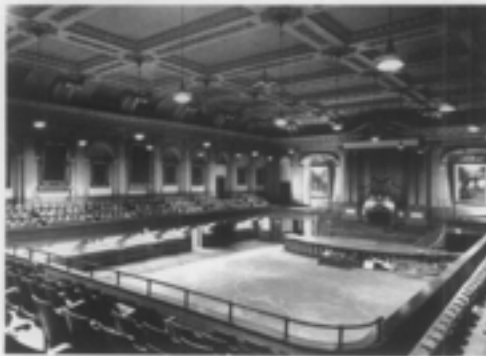
Figure 4. Many institutional buildings possess distinctive spaces or floor plans that are important in conveying the significance of the property. Finding new compatible uses for these buildings and preserving the buildings' historic character can be a difficult, if not impossible, task. One such case is Mechanics Hall in Worcester, Massachusetts, constructed between 1855 and 1857. This grand hall, which occupies the entire third floor of the building, could not be subdivided without destroying the integrity of the space.

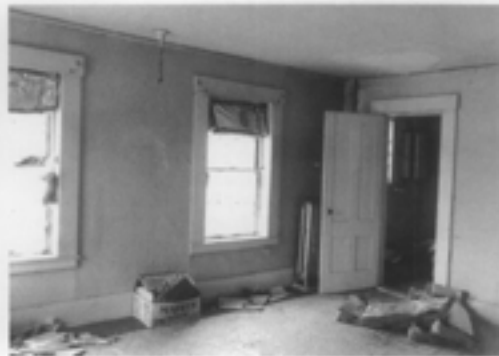
Figure 5. The interior of a simply detailed worker's house of the 19th century may be as important historically as the richly ornamented interior seen in figure 1. Although the interior of this house has not been properly maintained, the wide baseboards, flat window trim, and four-panel door are characteristic of workers' housing during this period and deserve retention during rehabilitation.

Features and finishes, even if machine-made and not exhibiting particularly fine craftsmanship, may be character-defining; these would include pressed metal ceilings and millwork around windows and doors. The interior of a plain, simple detailed worker's house of the 19th century may be as important historically as a richly ornamented, high-style townhouse of the same period. Both resources, if equally intact, convey important information about the early inhabitants and deserve the same careful attention to detail in the preservation process.

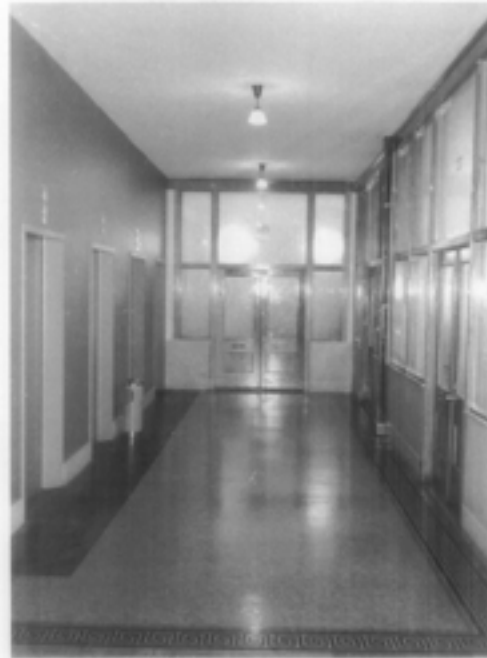
Figure 6. This corridor, located in the historic Monadnock Building in Chicago, has glazed walls, oak trim, and marble wainscoting, and is typical of those found in late 19th and early 20th century office buildings. Despite the simplicity of the features, a careful attention to detail can be noted in the patterned tile floor, bronze mail chute, and door hardware. The retention of corridors like this one should be a priority in rehabilitation projects involving commercial buildings.

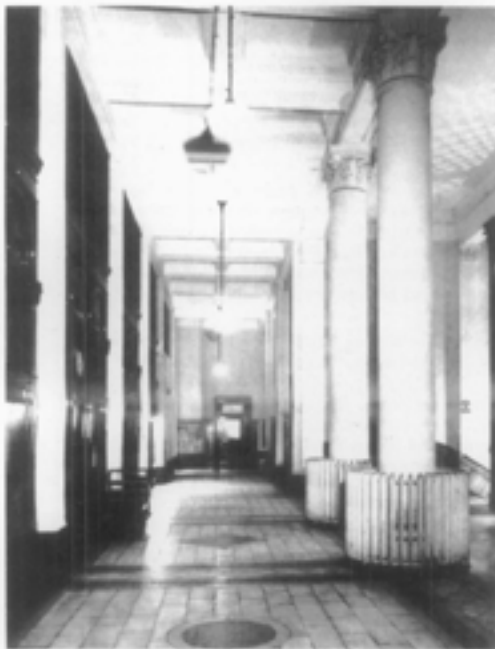
Figure 9. The tangible reminders of early mechanical systems can be worth saving. In this example, in the Old Post Office in Washington, D.C., radiators encircle Corinthian columns in a decorative manner. Note, too, the period light fixtures. These features were retained when the building was rehabilitated as retail and office space. Photo: Historic American Buildings Survey

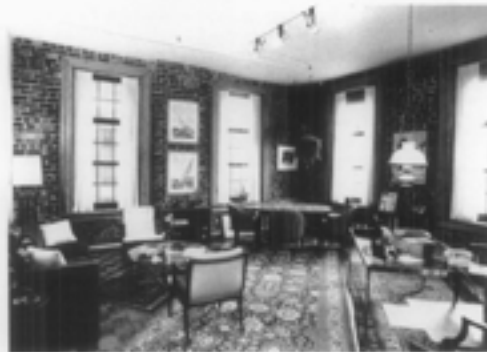
Figure 10. In this case plaster has been removed from perimeter walls, leaving brick exposed. In removing finishes from historic masonry walls, not only is there a loss of historic finish, but raw, unfinished walls are exposed, giving the interior an appearance it never had. Here, the exposed brick is of poor quality and the mortar joints are wide and badly struck. Plaster should have been retained and repaired, as necessary.

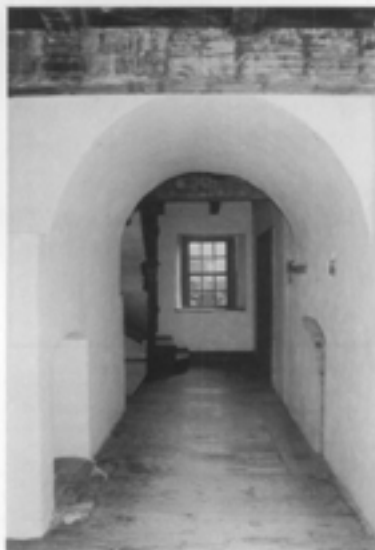
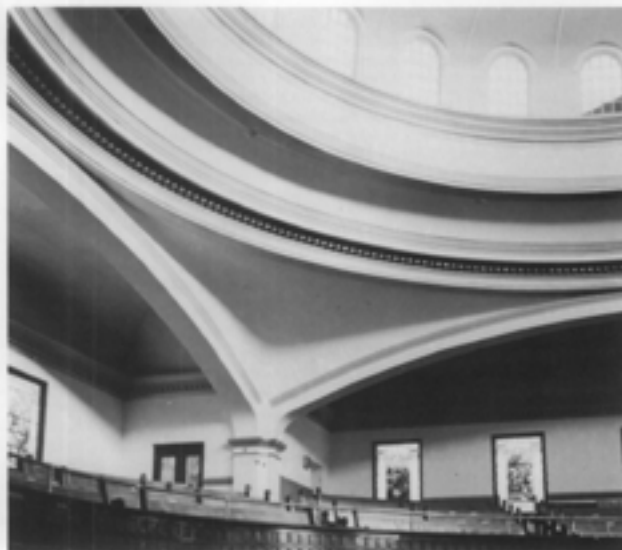
Fig. 1. Left: Schifferstadt, Frederick, Maryland, 1756. Right: First Christian Church, Eugene, Oregon, 1911. Although these two structures are separated in history by over 250 years and differences in size, ethnic origin, geography, construction techniques, and architectural character, their builders both used plaster as the interior surface coating for flat and curved walls. Photo left: Kay Weeks. Photo right: Kaye Ellen Simonson.

Plaster could be treated in any number of ways: it could receive stenciling, decorative painting, wallpaper, or whitewash. This variety and the adaptability of the material to nearly any building size, shape, or configuration meant that plaster was the wall surface chosen for nearly all buildings until the 1930s or 40s (Fig. 1).

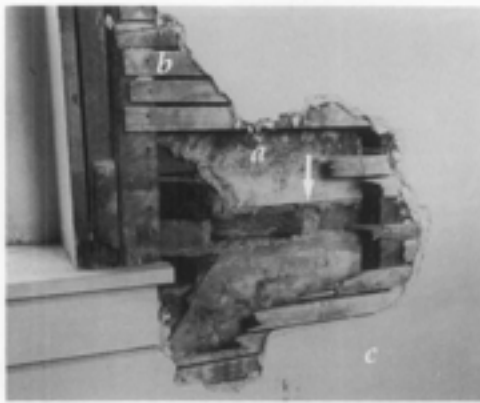
Fig. 2. A hole in the wall of a 1760s Custom House in Chestertown, Maryland illustrates the evolution of the room. (a) The original plaster was applied directly to an exterior masonry wall and the chair rail (missing here, see arrow) was in place before the wet plaster was applied to the wall. Sometime later when the interior was modified, the masonry was furred out. Machine-sawn wood lath (b) was nailed to the furring strips and (c) new three-coat plaster was applied. Photo: Maryland Historical Trust.

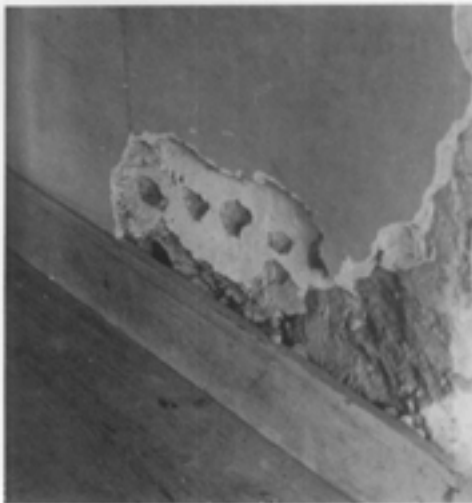
Fig. 4. The builders of this mid-18th century house installed the baseboard moulding first, then applied a mud and horse hair plaster (called paling) to the masonry wall. Lime was used for the finish plaster. Also shown are the backing marks which prepared the wall for a subsequent layer of plaster. Photo: Kay Wecks.

Not only did the basic plastering material change, but the method of application changed also. In early America, the windows, doors, and all other trim were installed before the plaster was applied to the wall (Fig. 4). Generally the woodwork was prime-painted before plastering. Obtaining a plumb, level wall, while working against built-up mouldings, must have been difficult. But sometime in the first half of the 19th century, builders began installing wooden plaster "grounds" around windows and doors and at the base of the wall. Installing these grounds so that they were level and plumb made the job much easier because the plasterer could work from a level, plumb, straight surface. Woodwork was then nailed to the "grounds" after the walls were plastered (Fig. 5). Evidence of plaster behind trim is often an aid to dating historic houses, or to discerning their physical evolution.

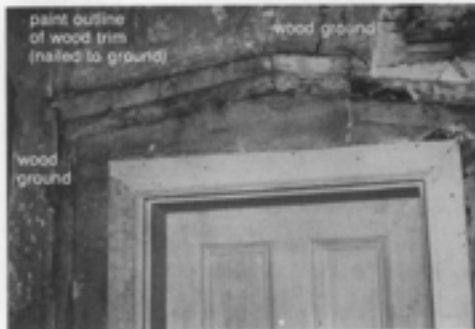
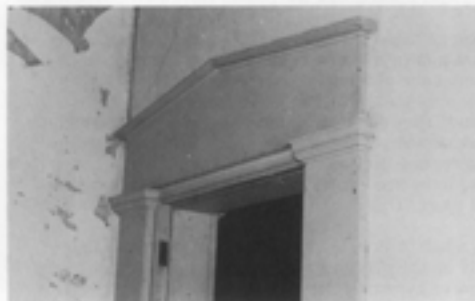
Fig. 5 (a). The photo above shows the use of wooden plaster "grounds" nailed to the wall studs of the mid-19th century Lockwood House in Harpers Ferry, West Virginia. This allowed the plasterer to work flush with the surface of the grounds. Afterwards, the carpenter could nail the finish woodwork to the ground, effectively hiding the joint between the plaster and the ground. The trim was painted after its installation, leaving a paint outline on the plaster. Fig. 5 (b). The photo below shows door trim and mouldings in place after the plastering was complete. Photos: Kaye Ellen Simonson.
