Preservation Briefs: The Use of Substitute Materials on Historic Building Exteriors

The Use of Substitute Materials on Historic Building Exteriors

Sharon C. Park, AIA

U.S. Department of the Interior
National Park Service
Cultural Resources
Heritage Preservation Services

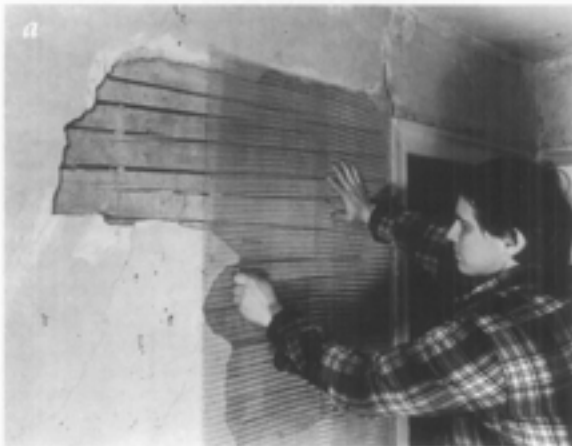
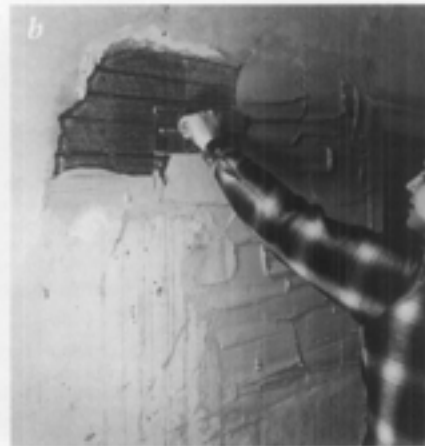
Fig. 10 (a) and (b). In this New Hampshire residence dating from the 1790s, the original plaster was a single coat of lime, sand, and horsehair applied over split lath. A one-coat repair, in this case, is appropriate. To the left: a flat sheet of galvanized expanded metal lath is placed over the patch area and an outline marked with a large soft lumber crayon. The metal lath is then cut to fit the hole and nailed to the lath. To the right: the edges of the original plaster and wood lath beneath have been thoroughly soaked with water. A steel trowel is used to apply the plaster in large, rough strokes. Finally, it will be scraped and smoothed off. Because only one coat of plaster is used, without a finish coat, a clean butt-joint is made with the original plaster. Photos: John Leek.

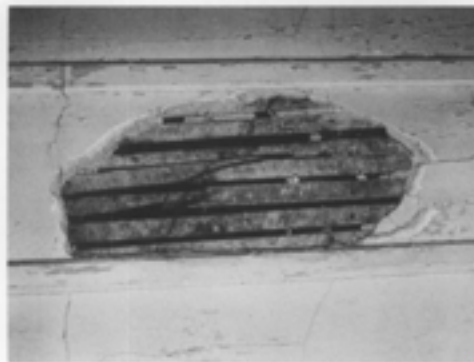
Fig. 13. This beaded ceiling in one of the bedrooms of the 1847 Lockwood House, Harpers Ferry, West Virginia, is missing portions of plaster due to broken keys. This is attributable, in part, to deterioration of the wood lath. Photo: Kaye Ellen Simonson.

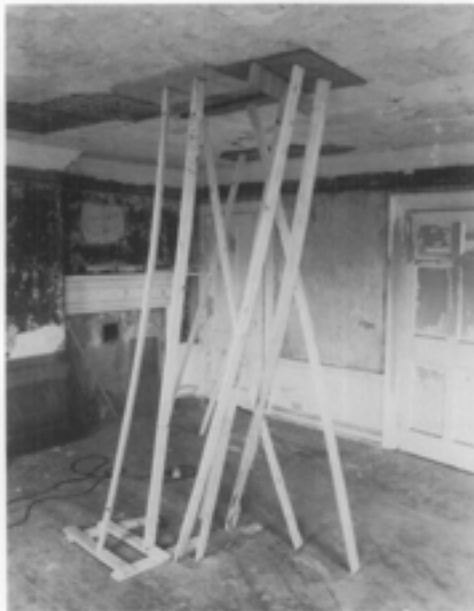
Fig. 15. When ceiling repairs are made with wet plaster or with an injected adhesive mixture, the old loose plaster must be supported with a plywood brace until re-keying is complete. Photo: John Leek.

Loose, damaged plaster can also be re-keyed when the goal is to conserve decorative surfaces or wallpaper. Large areas of ceilings and walls can be saved. This method requires the assistance of a skilled conservator—it is not a repair technique used by most plasterers. The conservator injects an acrylic adhesive mixture through holes drilled in the face of the plaster (or through the lath from behind, when accessible). The loose plaster is held firm with plywood bracing until the adhesive bonding mixture sets. When complete, gaps between the plaster and lath are filled, and the loose plaster is secure (Fig. 15).

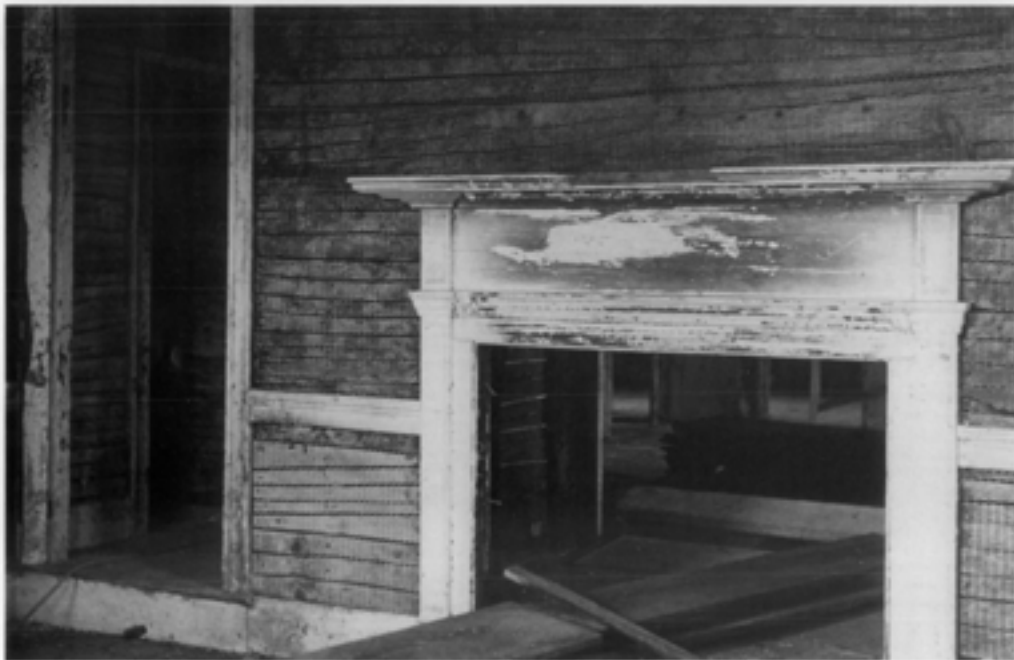
Fig. 16. In the restoration of a ca. 1830s house in Maine, split-board lath has been covered with expanded metal lath in preparation for new coats of plaster. This method permits the early lath to be saved while the metal lath, with its superior keying, serves as reinforcement. Photo: National Park Service files.

many of these problems can be avoided and the historic lath can be retained (Fig. 16). The ceiling should still be sprayed unless a vapor barrier is placed behind the metal lath.

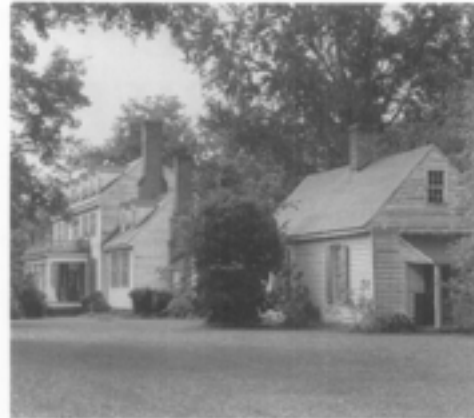
1. Eighteenth century and later vernacular architecture depended on the siting of the building, deciduous trees, cross ventilation, and the placement of windows and chimneys to maximize winter heating and natural summer cooling. Regional details, as seen in this Virginia house, include external chimneys and a separate summer kitchen to reduce fire risk and isolate heat in the summer. Photo: NPS Files.

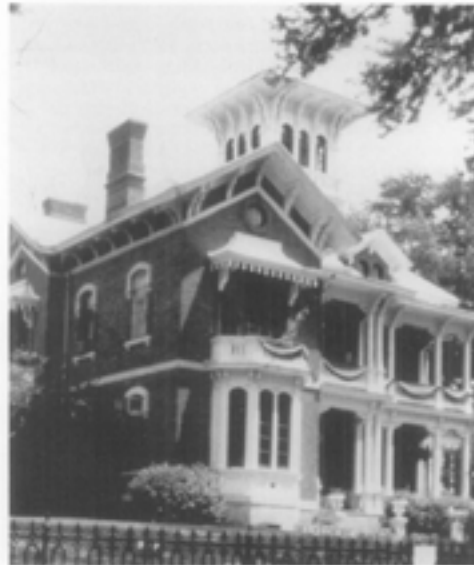
2. Nineteenth century buildings continued to use architectural features such as porches, cupolas, and awnings to make the buildings more comfortable in summer, but heating was greatly improved by hot water or steam radiators. Photo: NPS Files.

Nineteenth Century. The industrial revolution provided the technological means for controlling the environment for the first time (see figure 2). The dual developments of steam energy from coal and industrial mass production made possible early central heating systems with distribution of heated air or steam using metal ducts or pipes. Improvements were made to early wrought iron boilers and by late century, steam and low pressure hot water radiator systems were in common use, both in offices and residences. Some large institutional buildings heated air in furnaces and distributed it throughout the building in brick flues with a network of metal pipes delivering heated air to individual rooms. Residential designs of the period often used gravity hot air systems utilizing decorative floor and ceiling grilles.

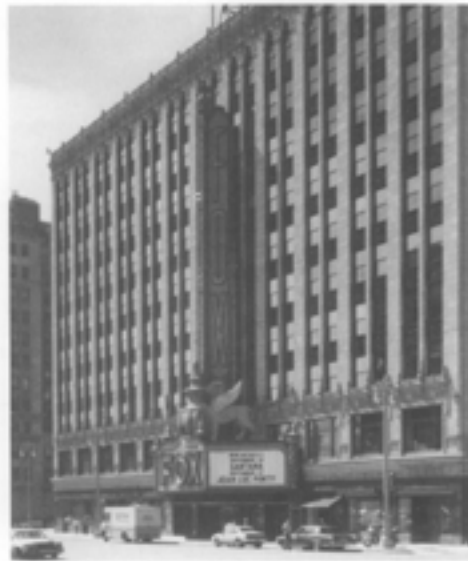
3. The circa 1928 Fox Theater in Detroit, designed by C. Howard Crane, was one of the earliest twentieth century buildings to provide air conditioning to its patrons. The early water-cooled system was recently restored. Commercial and highrise buildings of the twentieth century were able, mostly through electrical power, to provide sophisticated systems that integrated many building services. Photo: William Kesler and Associates, Architects.
